Oxygen Enhanced Fires in LD-3 Cargo Containers

May 1999

DOT/FAA/AR-TN98/29

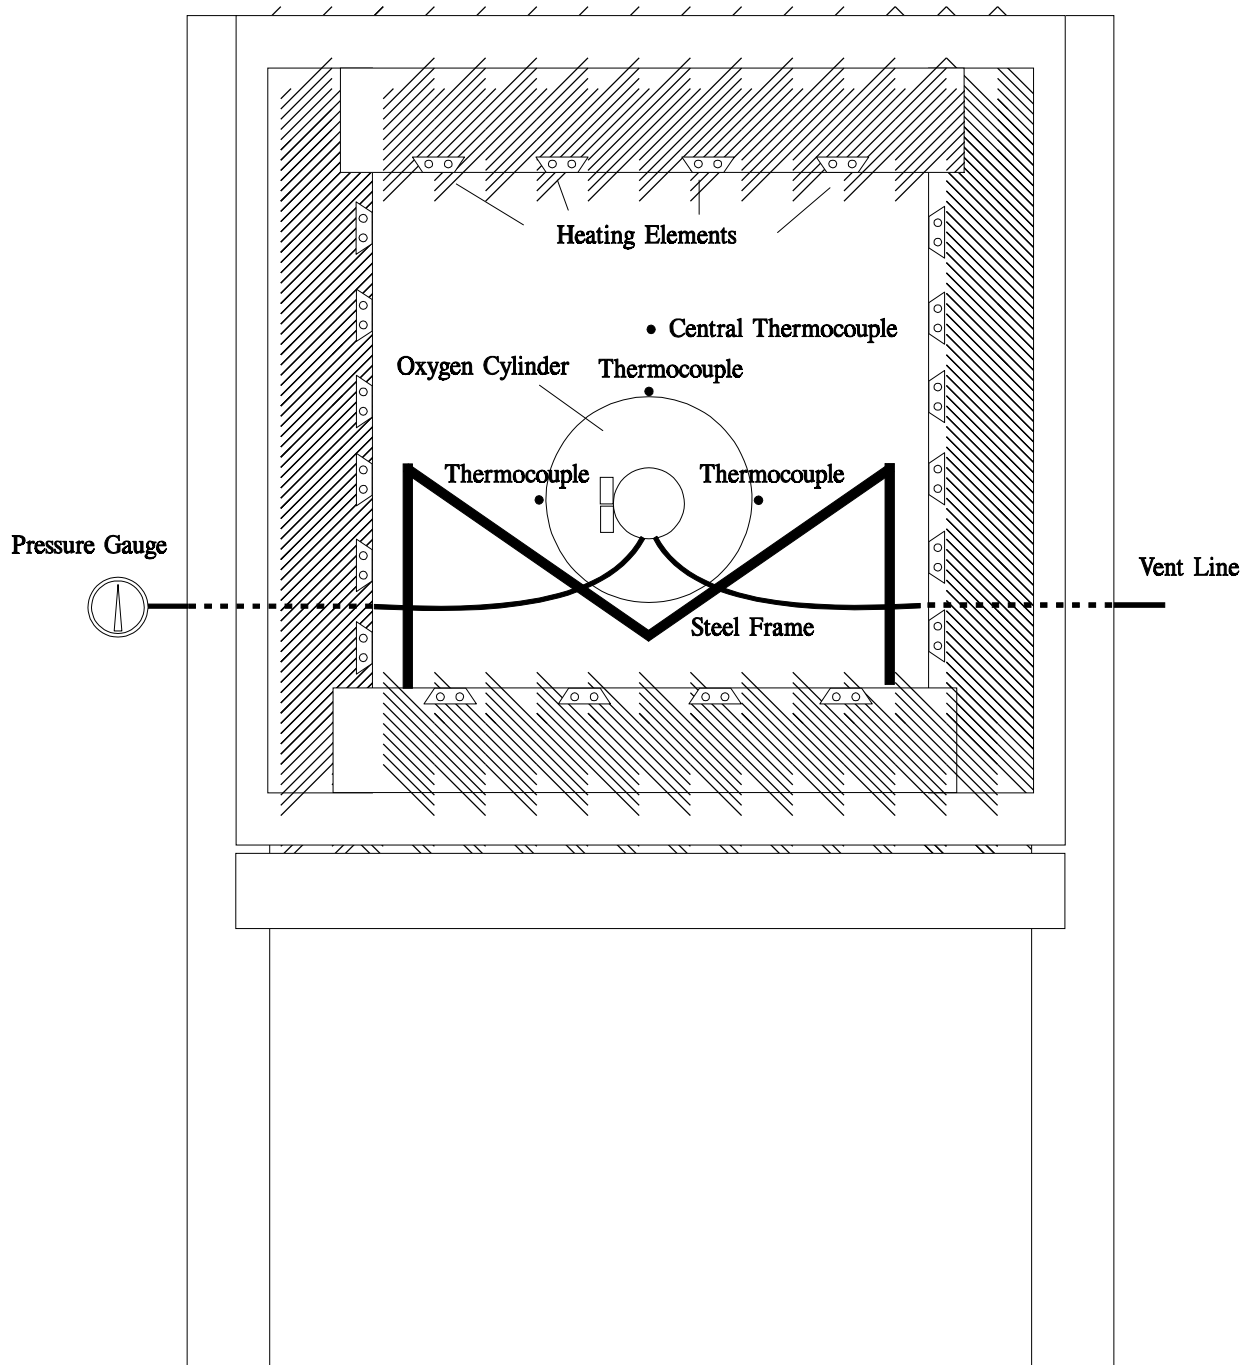
FIGURE 1. TEST FURNACE

A large, industrial-type high temperature electric box furnace was used for testing. The furnace was heated by means of coiled electric resistance-type alloy elements that are supported in hard ceramic element holders. The furnace insulation consists of a primary layer of lightweight

refractory insulating firebrick which is backed up with 2 inches of high temperature mineral fiber board. The temperature control system includes two separate zones of heating elements that are controlled independently with manual rheostat/bimetal percentage-type input controls. In addition, the overall furnace temperature is set by means of an automatic temperature control, which allowed ramping to 400°F in approximately 6 minutes. The internal dimensions of the furnace measured 37.5 by 26 by 25 inches (figure 1).

During the tests, the cylinders were attached to a steel frame that fit snugly into the test furnace to prevent cylinder movement and subsequent damage to the heating elements. The cylinder surface temperature was continuously monitored using three thermocouples attached directly to the cylinders. The furnace temperature was measured with a thermocouple located in the geometric center. A copper tube from the cylinder valve head was connected to a pressure gauge, allowing the internal pressure of the cylinder to be measured continuously during the heating process.

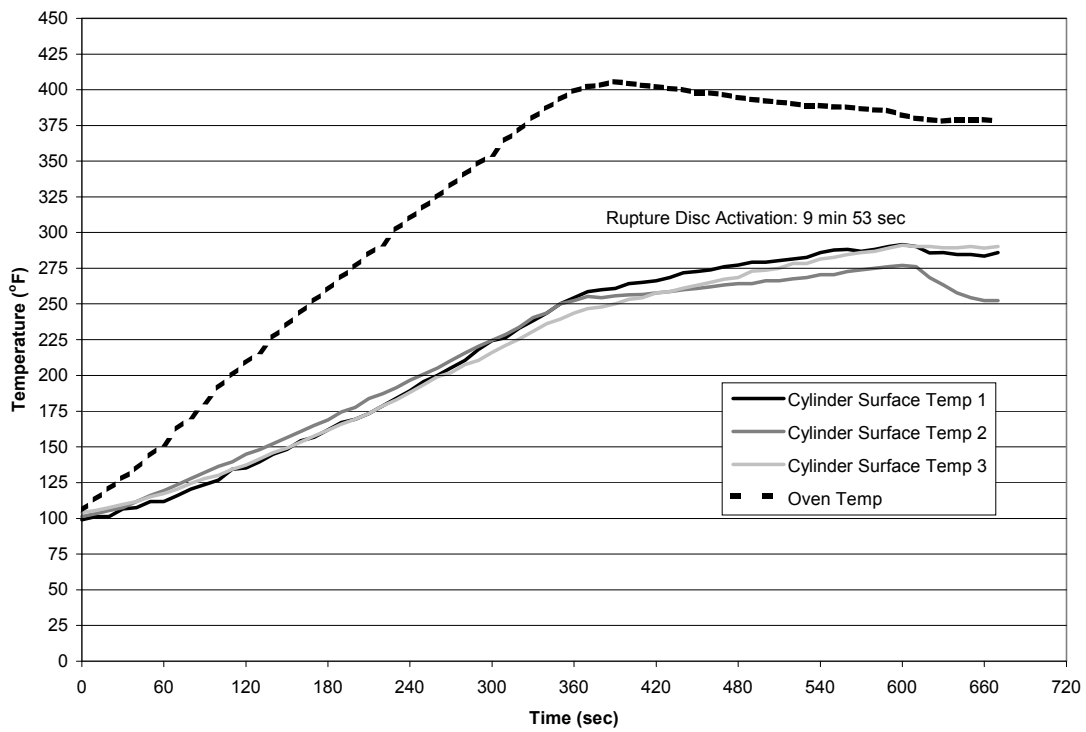
FIGURE 2. FURNACE TEST RESULTS USING A 76.5-CUBIC-FOOT CYLINDER

During the first furnace test, a 3HT-type, 76.5-cubic-foot cylinder was placed in the test frame holder. The cylinder measured 7.25 inches in diameter by 29.75 inches in length, excluding valve assembly. After the start of the test, the rupture disc activated at 9 minutes 53 seconds and required 33 seconds for the cylinder to fully evacuate. The temperature of the cylinder was 285°F, and the temperature inside the furnace was approximately 380°F at the time of release (figure 2). The cylinder internal pressure was approximately 2650 psi at the time of rupture disc activation. A second test was run under nearly identical conditions using a larger 115-cubic-foot cylinder that measured 9.00 inches by 29.56 inches. During this test, the rupture disc activated at 15 minutes 23 seconds and required 1 minute 12 seconds to fully empty. At the time of disc failure, the internal pressure was 2600 psi, and the cylinder surface temperature ranged between 300 and 320°F (figure 3). A final test was run using a small, 11-cubic-foot “walkaround” bottle that is typically used by flight attendants in the event of cabin depressurization. The cylinder was a type 3AA and measured 3.25 by 18.75 inches. A malfunction with the furnace temperature control resulted in a lengthy heating period; however, the rupture disc activated during temperature ramp-up at 17 minutes 12 seconds. The furnace temperature had reached between 350 and 370°F during release, at which point the cylinder surface temperature was between 300 and 325°F. The cylinder required only 5 seconds to fully discharge, and the pressure was observed to be approximately 2500 psi (figure 4). The average rate of release of nitrogen from the three cylinders was calculated to be approximately 2 ft³/sec.

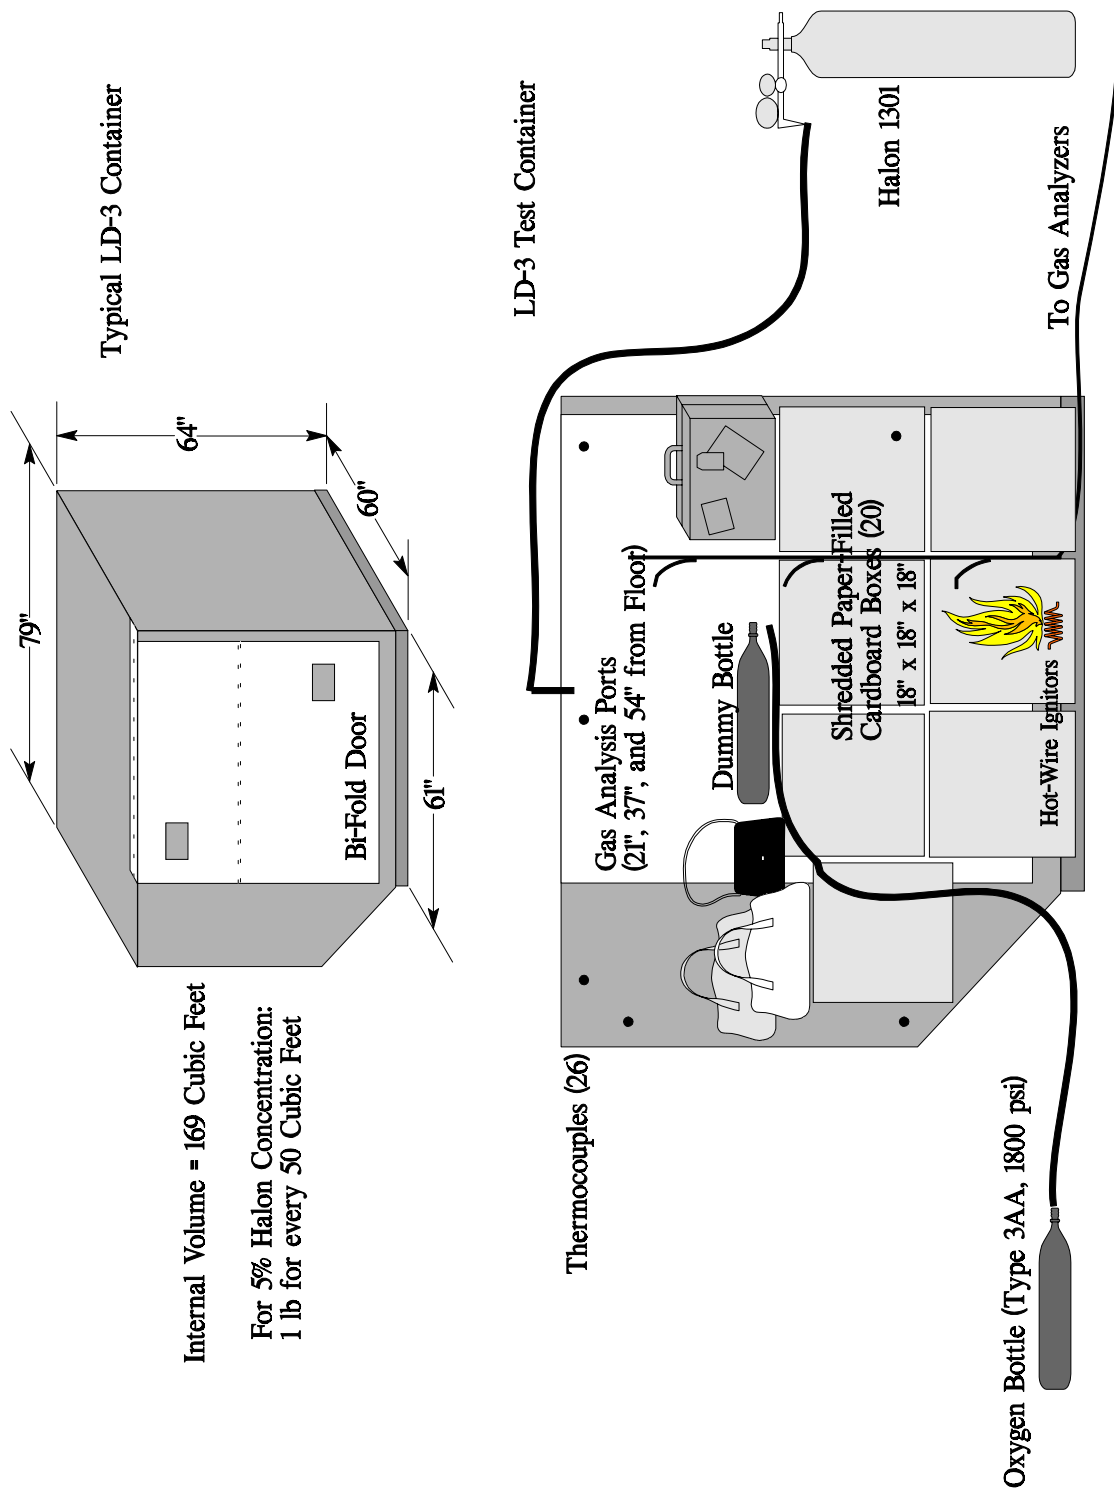
FIGURE 5. TEST 1 ARRANGEMENT IN AN LD-3 CARGO CONTAINER

In order to determine the impact of oxygen release during a fire, a steel-framed receptacle was constructed in the shape of an LD-3 container, which is typically used in the lower lobe of wide-bodied aircraft (DC-10, B-747, B-767, and L-1011). The test container had an internal volume of 169 cubic feet and could be rebuilt in the event of sidewall or ceiling damage. Sheet steel was used on most of the surfaces except for the top and front side, which was aluminum (0.63 inch thick). The fire load consisted of shredded paper-filled cardboard boxes measuring 18 by 18 by 18 inches. The boxes were loaded into the container in two tiers, each containing 9 boxes. An additional 2 boxes were loaded into the container for a total of 20. Thermocouples were placed on the four sides and ceiling of the test container. A gas sampling station contained intake ports at heights of 21, 37, and 54 inches from the floor. These lines passed through a series of filters prior to entering the gas analyzers, which continuously monitored the concentration of carbon monoxide (CO), carbon dioxide (CO₂), oxygen (O₂), and Halon 1301. A large, 1000-lb. Halon 1301 tank was available for fire suppression. A 0.375-inch diameter transfer line from the tank discharged halon from the center of the test container ceiling (figure 5).

During the first test several small rag-filled duffel bags and a large suitcase were also placed on top of the shredded paper-filled boxes (figure 5). The dummy cylinder was placed amongst this luggage which was also the area where the gaseous oxygen was discharged.

After ignition of the paper-filled fire box, the fire was allowed to develop for approximately 18 minutes, at which point the temperature in the fire box had reached 600°F, and a large amount of smoke was emanating from the edges of the container. Halon 1301 was then discharged into the LD-3 container, initially reaching a concentration of 8% at the top station (54 inches from the floor). The Halon 1301 concentration was allowed to decay until 30 minutes into the test where it had decreased to between 3.5% and 4.0%. At this point, the 11-cubic-foot oxygen cylinder was opened, but a problem with the valve prevented a rapid discharge. Instead of emptying in 5 seconds, as evidenced during the furnace test, the bottle required approximately 2 minutes to fully discharge. A review of the test data indicated the oxygen concentration inside the container rose from approximately 7% to 16% during the discharge. Slight increases in temperature were observed, but the oxygen release had little overall impact on the fire. The aluminum container ceiling did not allow flames to burn through at any time. At 60 minutes, the container was opened and the remaining fire was extinguished. Much of the original fire load was intact, as only 6 of the 20 boxes were burned, and there was no evidence of fire in and around the area of oxygen release.

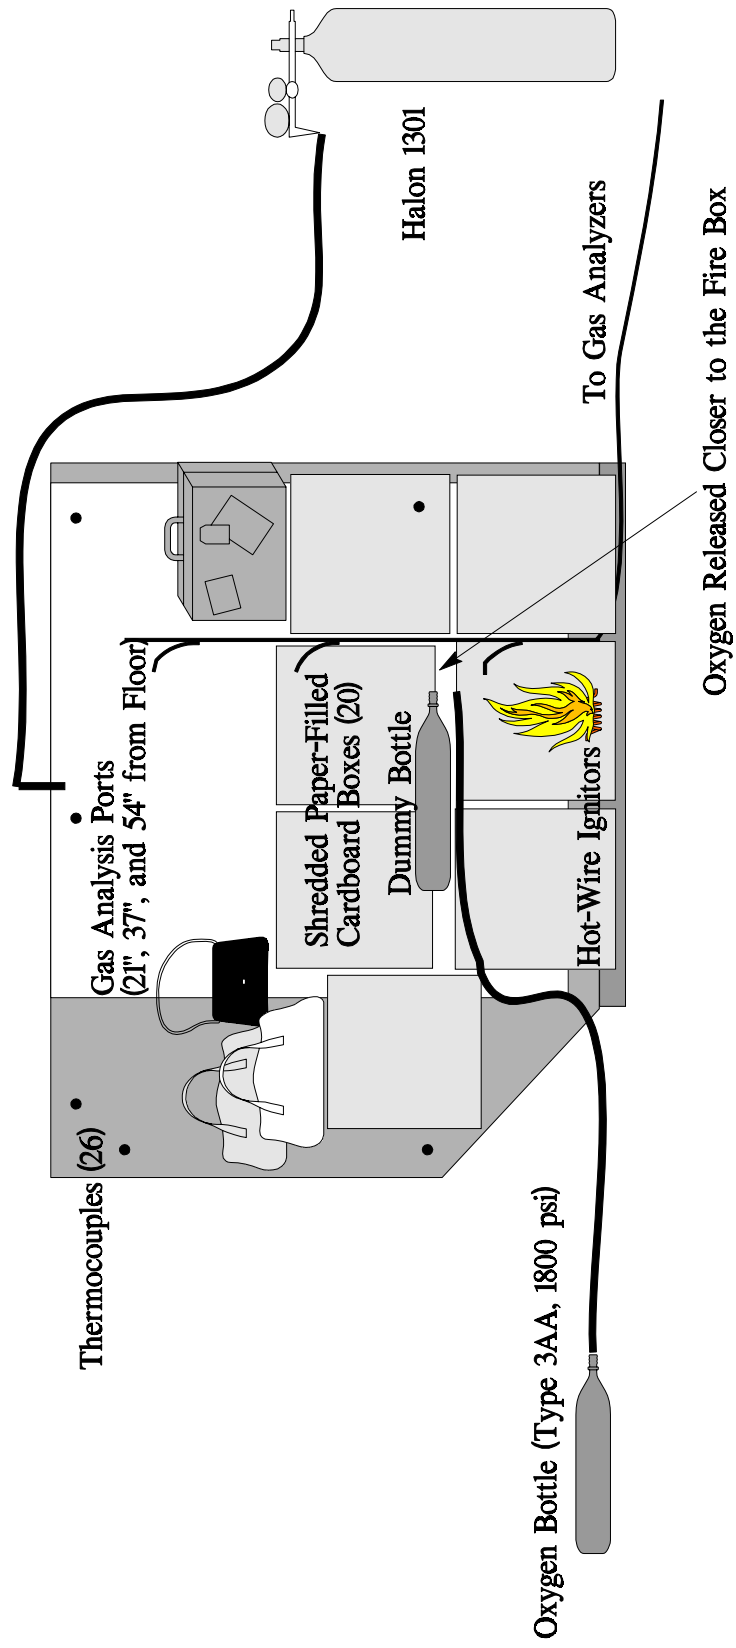
FIGURE 6. TESTS 2 AND 3 ARRANGEMENT IN AN LD-3 CARGO CONTAINER

Because the pressurized oxygen was not released into the fire at the appropriate rate, an identical test was run during which several adjustments to the test setup and execution were incorporated. First, it was determined that by switching to an alternate valve port the contents of the oxygen cylinder could be released in a much shorter duration (5 seconds). Second, the oxygen was released closer to the fire box in order to increase the chance of direct interaction with flaming combustion (figure 6). Third, the LD-3 container was modified to allow for more ventilation which would provide quicker fire development.

During the second test, the fire developed more rapidly, and Halon 1301 was deployed 3 minutes into the test. The concentration of halon reached 10% then slowly tapered off, but the fire was nearly extinguished by the high halon concentration. In order to continue with the test, a second ignition source was activated inside the box at approximately 14 minutes. The temperatures

began to increase, and the oxygen was released at 17 minutes (the halon concentration was approximately 3.8% at the time of oxygen release). Upon release, the smoldering fire erupted violently, as observed via video monitors. Visible flames appeared at one edge of the LD-3 container. Although violent, the eruption was short in duration, and the fire was contained. The fire did not burn through the aluminum ceiling of the container. When the oxygen was released, the concentration was initially 15%, but quickly reached 24%. The test was allowed to progress an additional 23 minutes (40-minute total) without interruption. At this point, the test was terminated, and the container was opened for extinguishment of any remaining fire. Approximately 50%-60% of the fire load (cardboard boxes) was undamaged. Although the test was executed as planned, there was concern over the amount of oxygen released into the fire, as a pre-existing leak in the cylinder valve was discovered just prior to the test. For this reason, the test was repeated in an identical manner.

During the repeat test (test 3), the fire was initiated in an identical fashion, but the Halon 1301 was bled into the container more slowly, to simulate a more realistic condition with the container inside a totally flooded compartment at 3% halon concentration. After 31 minutes, the temperature inside the fire box was approximately 800°F, and the oxygen concentration inside the container was about 8%. At this point, the oxygen was discharged. The release of oxygen again caused a violent reaction inside the container that produced enough pressure to force open taped seams on the container at several locations. Although the event produced elevated temperatures inside the fire box (1300°F), it was again very short in duration much like the previous test. After about 30 seconds, the temperatures inside the box appeared to be even lower than the prerelease conditions. Apparently, the oxygen release had resulted in an intense combustion period, leaving reduced levels of oxygen and temperature. Halon was continually bled into the container during the test to maintain a 3% concentration, and the test progressed from this point on for another 18 minutes (50-minute total) without incident.

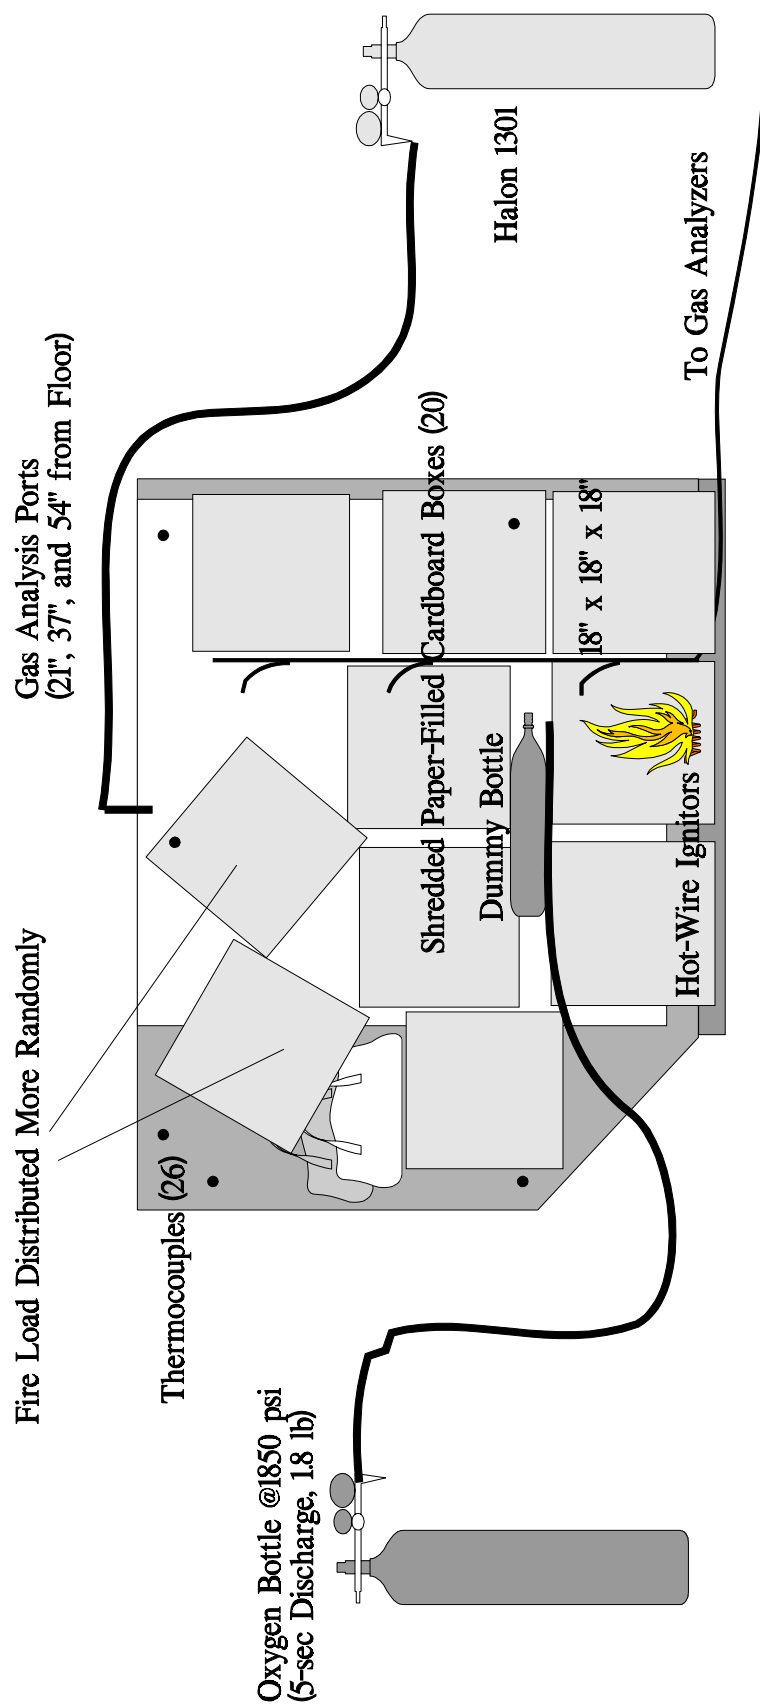
FIGURE 7. TEST 4 ARRANGEMENT IN AN LD-3 CARGO CONTAINER

Although the 11-cubic-foot oxygen release produced a severe condition inside the container, because of the short duration, it did not overcome the suppression capabilities of the Halon 1301. Since the planned test effort was to continue introducing greater but realistic oxygen quantities into the container in order to examine fire suppression capabilities of halon, twice the amount of oxygen was used in the fourth test. In an effort to expedite testing, a large welding torch oxygen cylinder was acquired and fitted with a manual on-off 90-degree valve. This allowed subsequent tests to be conducted at various discharge quantities, alleviating the need to purchase expensive cylinders of various sizes. It was predetermined that 22 cu ft of oxygen weighed 1.8 lb., so the cylinder was placed on a digital scale and the time required to release this amount from the cylinder was measured. This was observed to be 5 seconds. The execution of the test remained identical to the previous three, except for a minor deviation in the loading of the cardboard boxes, which were placed more randomly to allow for greater air circulation and better fire development (figure 7).

During the fourth test, one of the three dummy cylinder thermocouples had reached a temperature in excess of 300°F at approximately 6 minutes. Since one of the other two dummy cylinder thermocouples appeared to be malfunctioning, a determination was made to allow the test to progress a little further, since the remaining thermocouple was still well below 300°F. At

12 minutes 30 seconds into the test, the conditions were right for oxygen release, as the halon concentration was between 3% and 3.2%. Upon release, the front surface of the container was partially blown off, and flames shot out around the periphery in a violent fashion. An attempt was made to maintain the halon concentration at 3% to simulate a container inside a flooded compartment, but all of the gas analysis intake ports were clogged, so there was no way of tracking the concentration. As the test progressed, flames began to burn through the aluminum ceiling. After 21 minutes, the flames were extinguished but not before burning completely through the ceiling and part of the front side of the container, totally destroying it. A review of the thermocouple data indicated dramatic increases in temperature in the container four walls and ceiling immediately following the oxygen release.
